Who Moved My Cheese?

By Dr. Spencer Johnson

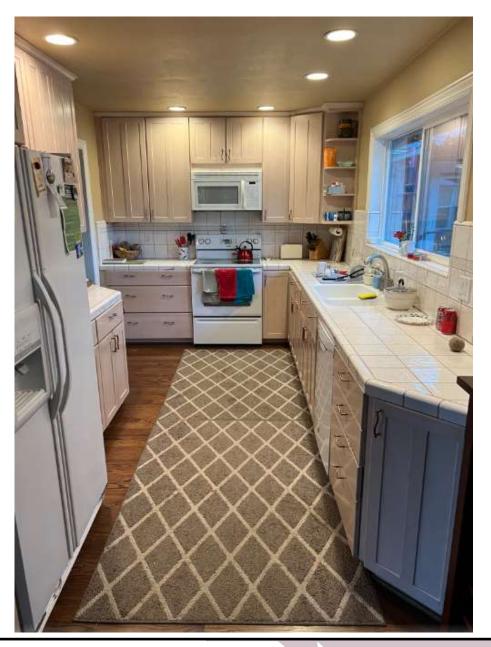
Prompt: "Please describe this room, what it is and the appliances. Comment on its condition and quality using a scale of 1 to 6 with 1 being excellent condition and quality"
